Manhole Inspection Summary

Manhole # S15OO1003MH

Location Address: **4800 YELLOWWOOD AVE**

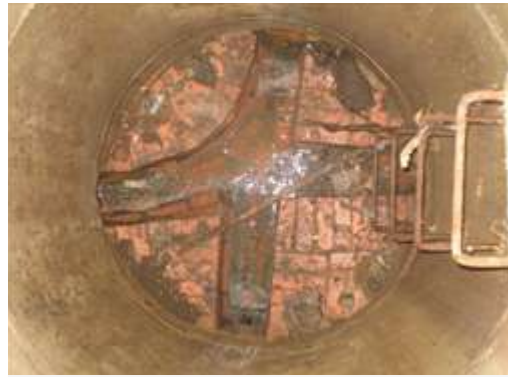
Top View

☐ Parged ☒ **Debris** (not Condition related)

Count: **6** Missing: **0** ☒ **Corroded**

☒ **Evidence Of Surcharge**

Corroded steps. Evidence of surcharge - Bench debris.

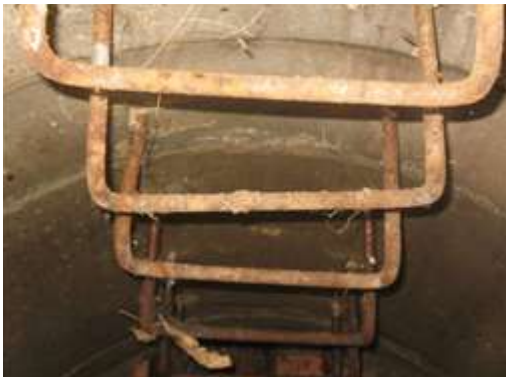
Defect

Infiltration: ☐ None ☒ **Joint** ☐ Cracks ☐ Mortar ☐ Roots ☐ Wall

Infiltration: ☐ None ☐ Joint ☐ Cracks ☐ Mortar ☐ Roots ☒ **Wall**

Corbel and Barrel infiltration. Corroded steps.

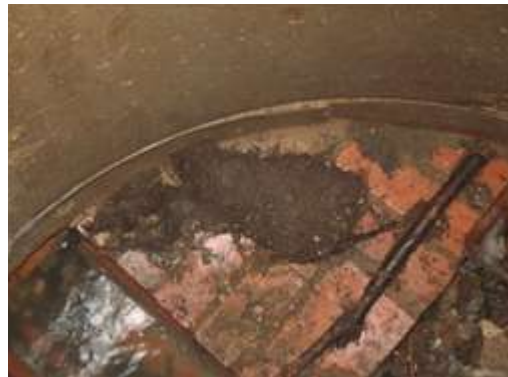
Defect

Condition: ☐ Sound ☐ Cracked ☒ **Root Intrusion** ☐ Deteriorated ☐ Leaks ☐ Debris

Bench root intrusion.

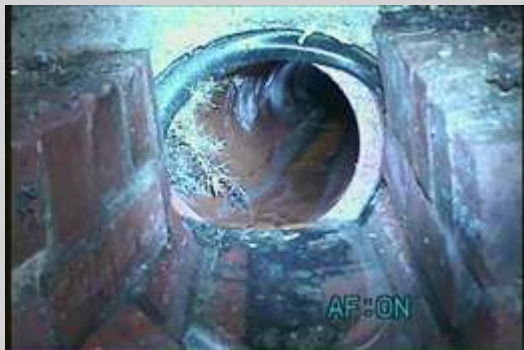
8 in. Circular Gravity Sewer Pipe Out @ 12 O'Clock

Infiltration: **Evidence** Pipe Seal Cond: **Roots**

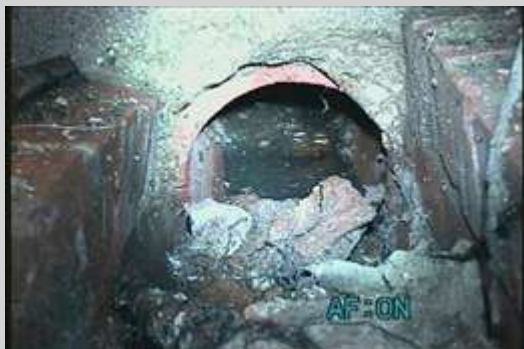
6 in. Circular Gravity Sewer Pipe In @ 3 O'Clock

DEBRIS IN CHANNEL

Deposits: ☐ None ☒ Mud ☐ Sludge ☒ Debris ☐ Grease

Silt Depth: **2** (in.) Deposits Extent: **Light**

Infiltration: **Evidence** Pipe Seal Cond: **Unknown**

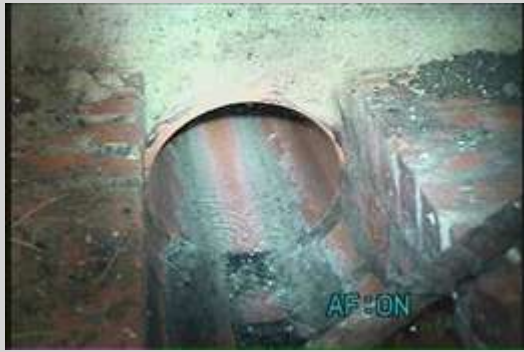
Pipe In @ 6 O'Clock

Deposits: ☐ None ☐ **Mud** ☐ Sludge ☐ **Debris** ☒ **Grease**

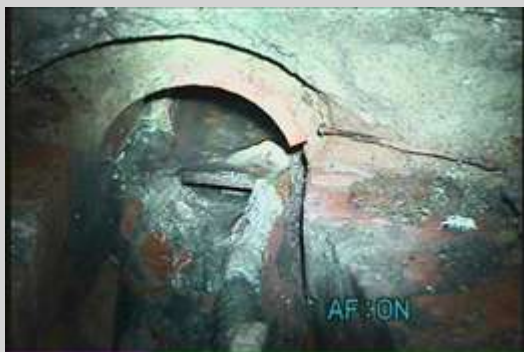
Pipe In @ 9 O'Clock

DEBRIS IN CHANNEL

Deposits: ☐ None ☒ **Mud** ☐ Sludge ☒ **Debris** ☒ **Grease**

Infiltration: **Evidence** Pipe Seal Cond: **Unknown**
